Manhole Inspection Summary

Manhole # S29G__021MH

Insp Date: **4/3/09 7:30 AM**

Location Address: **10 BALTIMORE ST**

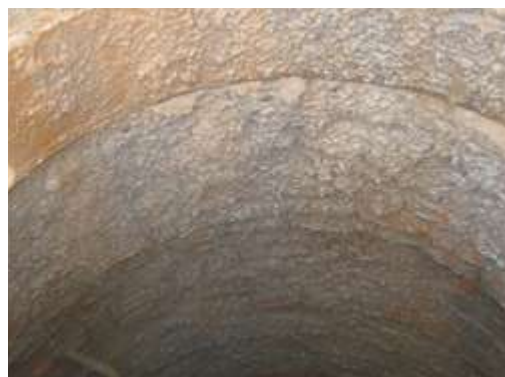
Defect 3

Frame Offset: **0** (in.) Condition: ☐ Sound ☐ Cracked ☒ **Leaks**

LID/FRAME INFILTRATION

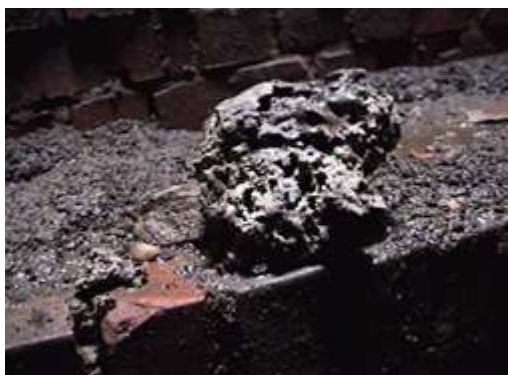
Defect 2

Condition: ☐ Sound ☒ **Cracked** ☐ Root Intrusion ☐ Deteriorated ☐ Leaks ☒ **Debris**

DEBRIS ON BENCH, CRACKED BRICK
MISSING MORTAR

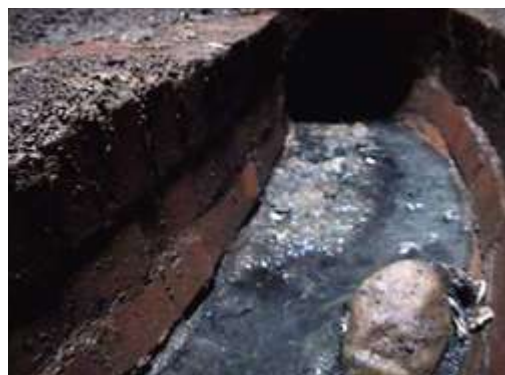
Defect 1

Condition: ☐ Sound ☐ Cracked ☐ Root Intrusion ☐ Deteriorated ☐ Leaks ☒ **Debris**

DEBRIS IN CHANNEL

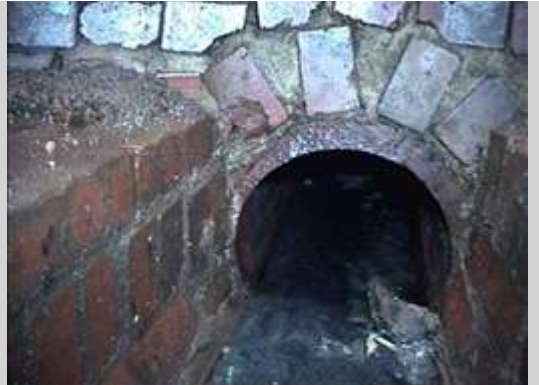
12 O'Clock Outflow

10 in. Circular Gravity Sewer
Pipe Out @ 12 O'Clock

Pipe Height: **10.8** (in.) Rod and Bar (Angled)
Pipe Material: **Clay** ☐ Pipe Lined
Invert Depth: **14.15** (ft.) Flow Characteristics: **Slow**
Deposits: ☒ None ☐ Mud ☐ Sludge ☐ Debris ☐ Grease
Silt Depth: **0** (in.) Deposits Extent:
Infiltration: **None** Pipe Seal Cond: **Sound**

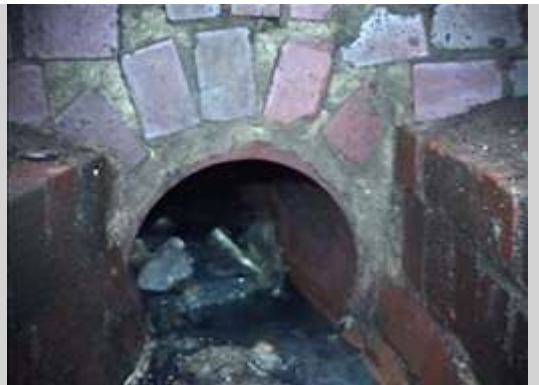
5 O'Clock Inflow

10 in. Circular Gravity Sewer
Pipe In @ 5 O'Clock

Pipe Height: **10.8** (in.) Rod and Bar (Angled)
Pipe Material: **Clay** ☐ Pipe Lined
Invert Depth: **14.04** (ft.) Flow Characteristics: **Slow**
Deposits: ☒ None ☐ Mud ☐ Sludge ☐ Debris ☐ Grease
Silt Depth: **0** (in.) Deposits Extent:
Infiltration: **None** Pipe Seal Cond: **Sound**
